VEHICLE INSPECTION REPORT

Date: [10 Mar 2015](#)

[LEXUS](#)

[LS460](#)

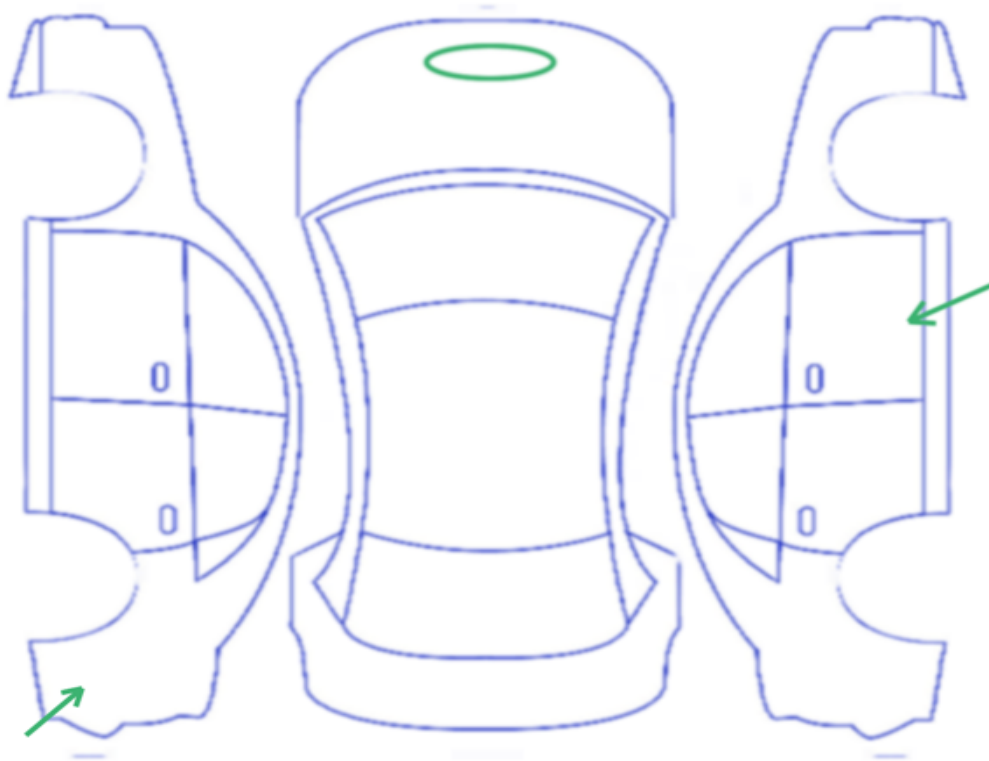
Body Panels have been tested and paint/coating thickness has been measured with a digital meter to detect any repairs.

Cosmetic Panel / paint = Green
Minor Scratches / Dents = Gray
Damaged / Dented = Black
Previous Body Repairs = Orange
Rust = Red

Added Notes: Minor chips/marks to windscreen, visibility ok check for RWC.
Vehicle has had minor panel and paint repairs to various panels
No evidence of any chassis or structural repairs found refer diagram.
