## VEHICLE INSPECTION REPORT

<b>Customer</b> Sample only	<b>Location</b> Mulgrave	
<b>Booking Code</b> 2708795	<b>Inspector</b> Willem	<b>Date</b> 12-11-2010
<b>Inspection Type</b> Platinum	<b>Make</b> Holden	<b>Model</b> Captiva

<b>Badged</b> CAPTIVA	<b>Registration Number</b> AX072B
<b>State Registered</b> Vic	<b>Body Colour</b> Grey
<b>Aust Compliance</b> 8/13	<b>Build Date</b> 8/13
<b>Odometer KM</b> 84127	<b>VIN Number</b> KL3CA26UJXYZ060030
<b>Engine Number</b> LE91480060	<b>Number of Cylinders</b> 4
<b>Number of Doors</b> 4	<b>Engine Type</b> PETROL
<b>Transmission Type</b> AUTOMATIC

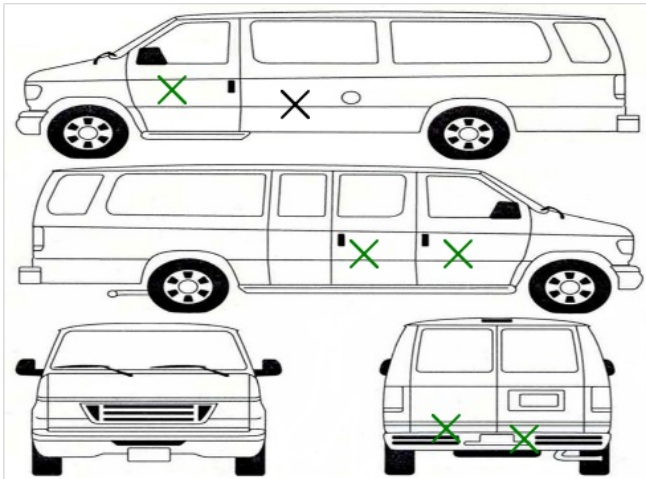
Vehicle shows no signs of body repairs - paint thickness is consistent with factory original thickness

No major damage visible at body - shell showing minor dents and scratches and cosmetic attention may be needed to improve overall appearance

**Cosmetic Panel / paint = Green**

**Minor Scratches / Dents = Grey**

**Damaged / Dented = Black**

**Previous Body Repairs = Orange**

**Rust = Red**
