VEHICLE INSPECTION REPORT

Make [BMW](#)

Model [M5](#)

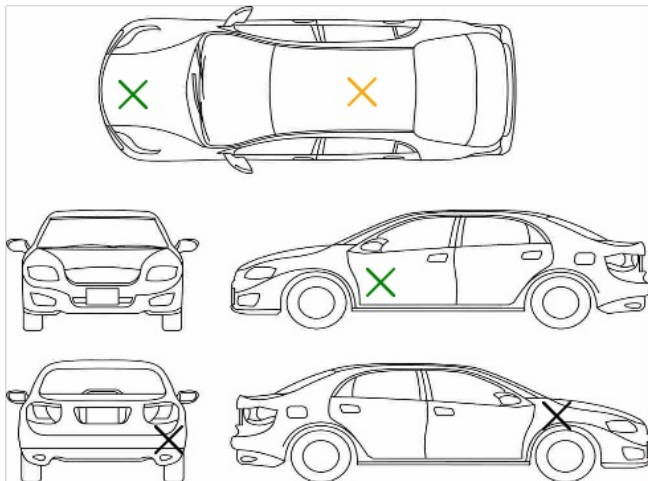
No structural previous accident repairs found, some minor work to paint finish detected and some shopping size dents and scratches still visible - purchaser advised to check body condition carefully before purchase for own satisfaction

Cosmetic Panel / paint = Green

Minor Scratches / Dents = Grey

Damaged / Dented = Black

Previous Body Repairs = Orange

Rust = Red
